INSPECTION REPORT

For the Property at:
4627 N NEWLAND
CHICAGO, IL

Prepared for: BOB ELLIOTT
Inspection Date: Thursday, March 1, 2007
Prepared by: robert elliott

ELLIOTT HOME INSPECTION

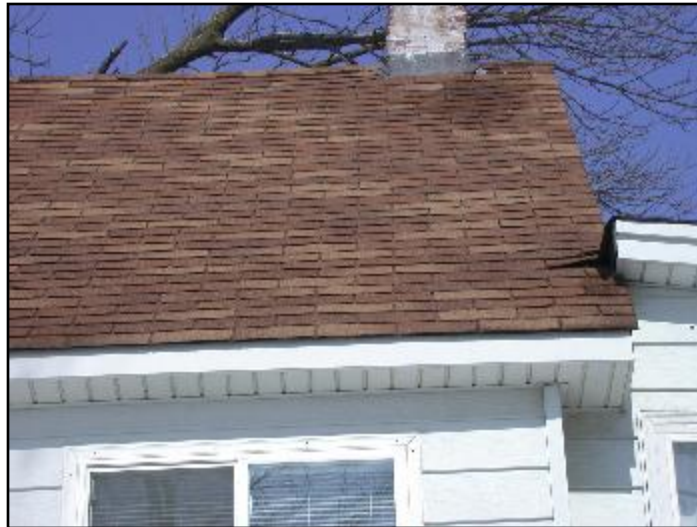
1. note lack of gutters

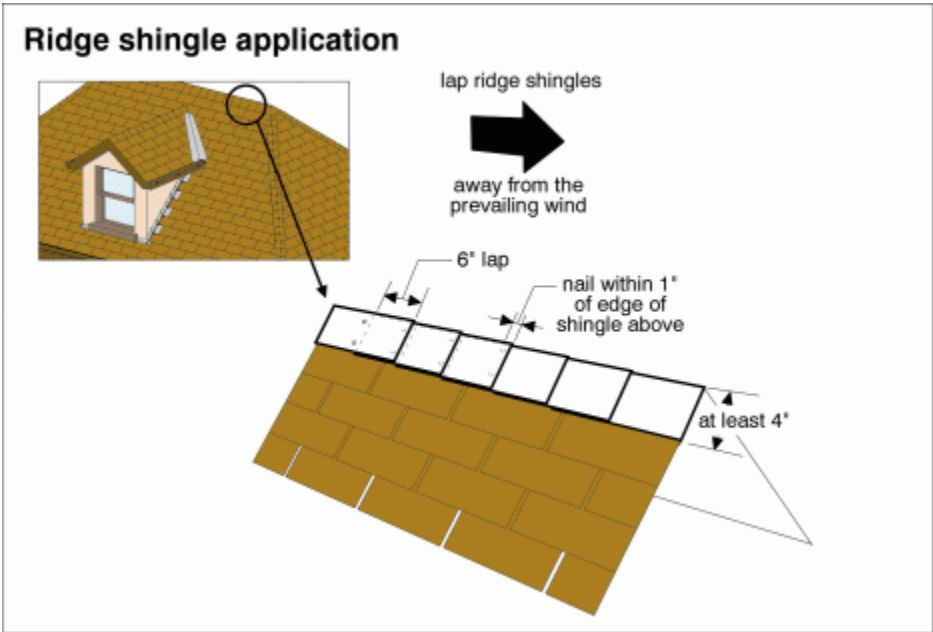
Sloped roof flashings \ Hip and ridge flashings

Condition: • [Loose, misaligned, missing](#)

Implication(s): Chance of water damage to contents, finishes and/or structure

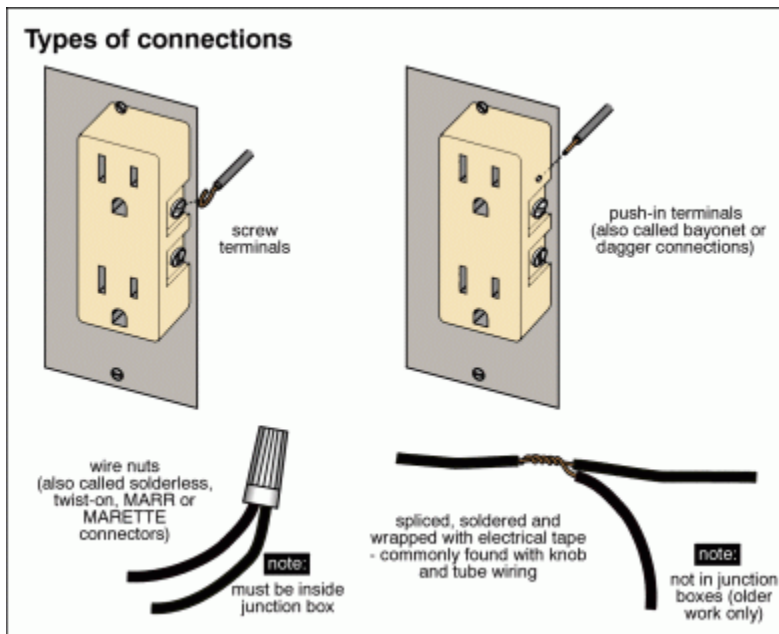
Distribution system \ Junction boxes

Condition: • [Missing, loose](#)

Implication(s): Electric shock | Fire hazard
